S-228 Old Butler Farm Near Cokesbury Private

c. 1900-1910

Maryland Historical Trust State Historic Sites Inventory Form

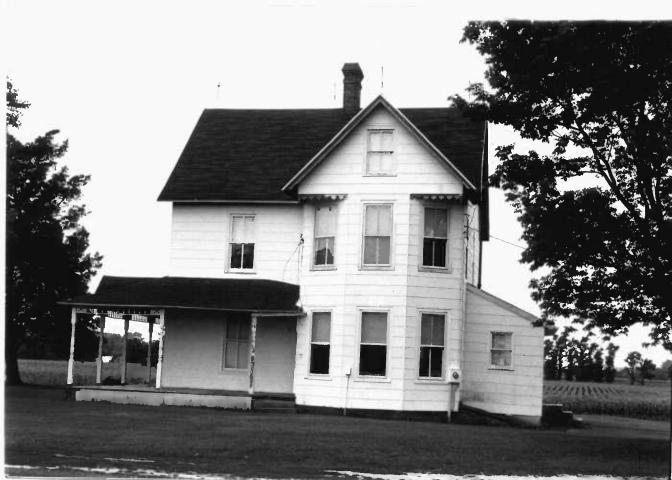
Old Butler Farm S-228
Cokesbury vicinity, Somerset Co., MD.
South elevation
7/84, Paul touart, Photographer
Neg./ MD. Hist. Trust

The south side has a two-story three-sided bay pavilion that is covered by a gable-front roof. The roof soffits on each corner are decorated with sawn work.

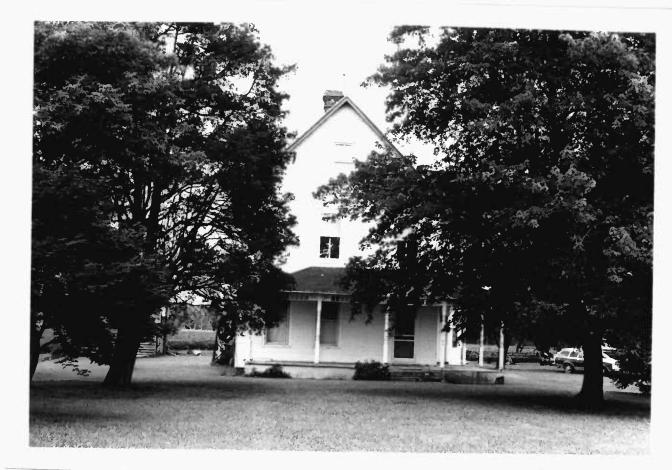
Old Butler Farm
Near Cokesbury, Somerset County
Southwest Elevation
6/84 Paul Touart
Neg/MD. Historical Trust

The west elevation is three bays across with an entrance in the south or right bay. The door is glazed above the lock rail and paneled below. The two adjacent openings are filled with single-pane sash windows. The second floor is lighted by three 2/2 sash windows and the attic has one 2/2 sash window. Stretching across the first floor and around the south side is a turned post porch with decorative trim between each post head. A small gable distinguishes the entrance bay, and it is decorated with sawn work. A star design is centered in the peak.

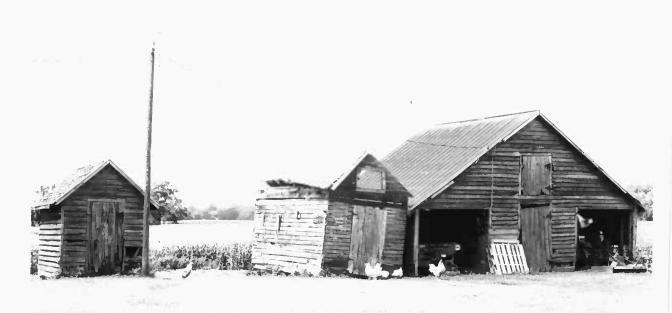
Old Butler Farm
Near Cokesbury, Somerset County
Outbuildings - Southeast Elevation
6/84 Paul Touart
Neg/MD. Historical Trust

The outbuildings stand within twenty yards of the kitchen door and are plain early twentieth century structures. According to the owner, the 18th-century house site is located next to the old pear tree that stands due east of the present farmhouse. The old house was moved up to a new site in the early 20th-century and used as a barn, until a wind storm twisted the frame. It was finally demolished several years ago.

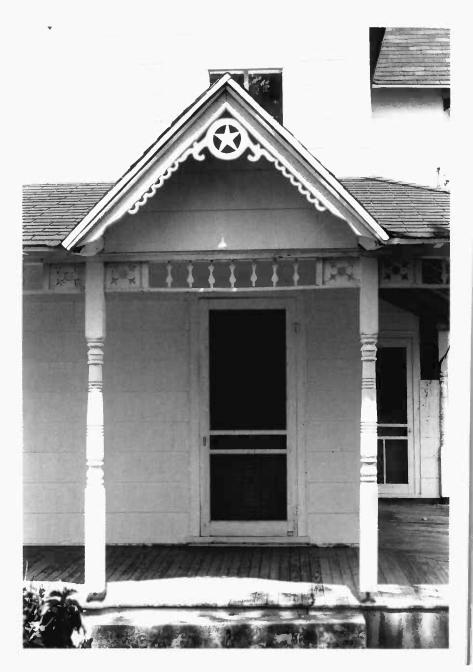
S-228

Old Butler Farm
Near Cokesbury, Somerset County
Porch Detail
Southwest Elevation
6/84 Paul Touart
Neg/MD. Historical Trust
